The following is some measurements and observations comparing a newly acquired (11/2022) "Open Box" Bach LR180S72 from "The Mighty Quinn", for a dramatic discount off new price (>\$1000). The question of course was, why the discount? This horn is Conn-Selmer "B Stock", a horn that has been used as a demo, or returned, or set-aside during plant Quality Control checks. The seller did not provide a basis for the B-Stock classification, but the tech, an accomplished player, put the horn through its paces over the phone and after I did the same, I would agree that it might be slightly brighter than expected, but (and this will become curious) has excellent intonation, and a good full tone. It plays freely and responds very easily. All-in-all, a great player. In comparing it to a standard-construction, fairly new (2009/10) 72, which had way less than 50 hours on it, I found it mechanically to be comparable to regular stock, except for a leadpipe anomaly unlike anything I have seen before. The pipe has debris attached to the wall that looks like silver powder. Given the intrusion into the taper, the intonation is quite a surprise, as this should corrupt the leadpipe functionally. As this

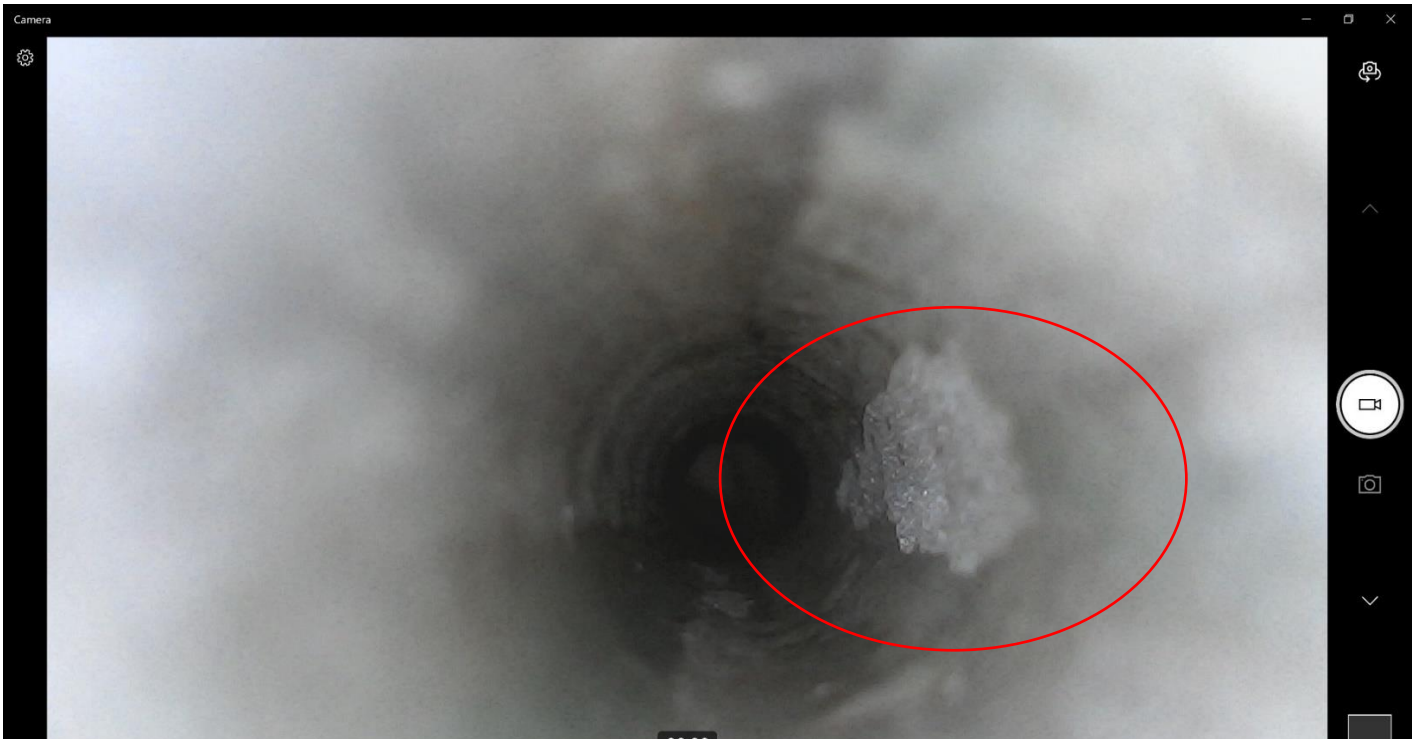
silvery powdery debris stuck to leadpipe wall near receiver

On the advice of Robb Stewart, I fashioned a means to scrape the wall of the leadpipe softly while watching through the borescope camera inserted from the other end. Using a 1/8" X 3/32" long oak probe, I approached the first spot. When splinters came off my probe accompanied by a crunching sound, I was worried that this would require more aggressive means such as the steel tools Robb uses for corrosion accumulation. However, the debris instantly lifted after that as I rotated the oak, and in the matter of a few minutes, everything in the leadpipe had been loosened and rinsed out. Problem solved.

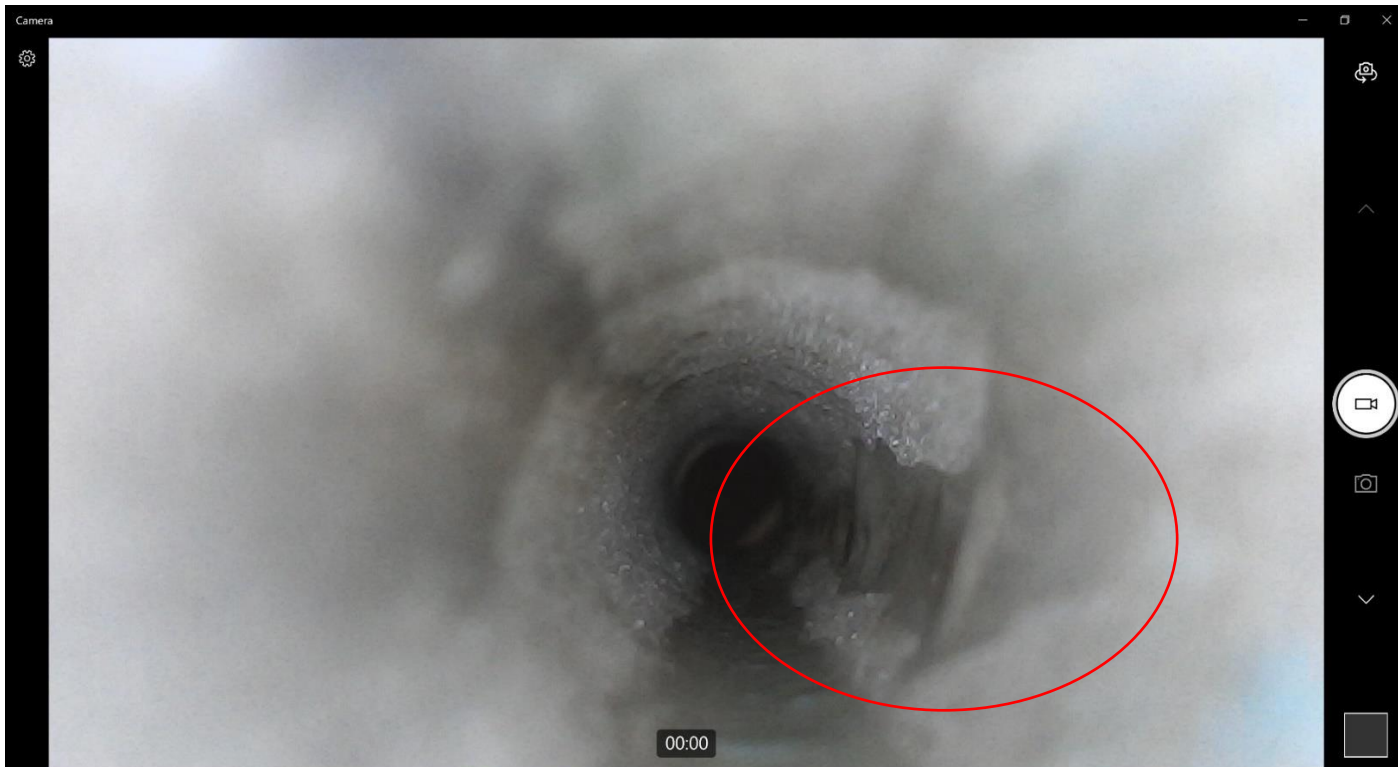
Far more powder build-up mid-run in leadpipe, with ridges of solid build-up on wall

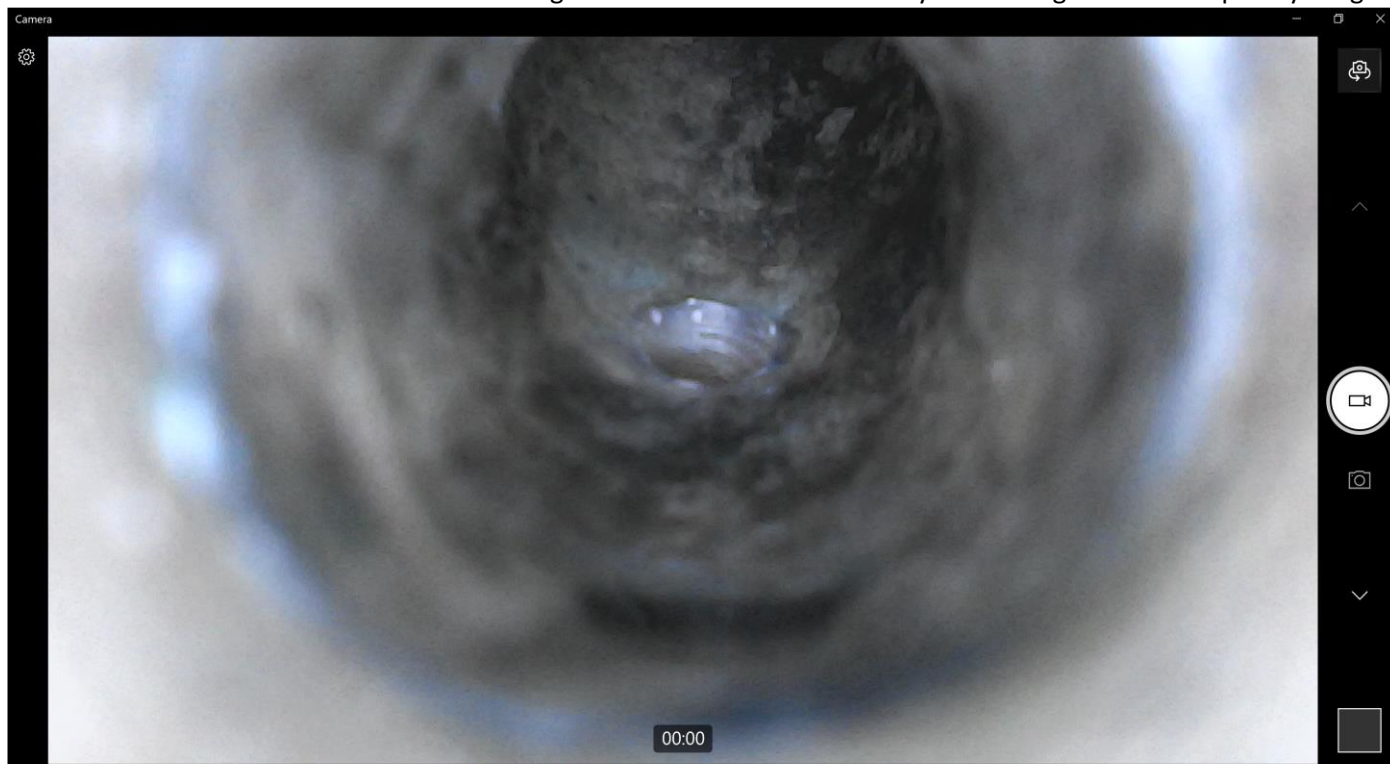
Then there was the real fear: debris coming loose as that silver went away & reaching the valves. Spit key caught some.
